<b>Health, Safety, Quality and Environmental Alert</b>	Alert number: 22-18	Document Reference: AMG/F/HSQE/001
	<b>Road Rail Vehicle runaway</b>	Issue Date: 22/06/18	Author: Steve Milroy

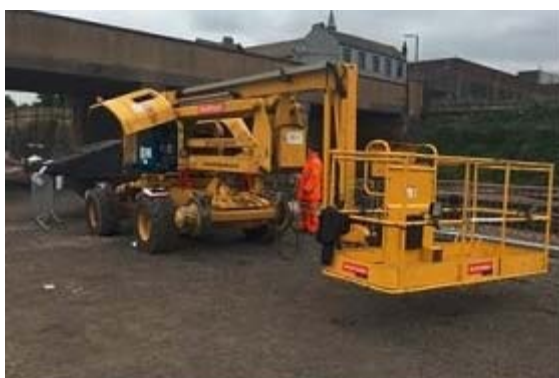
At 02:00 on 8 June at Bradford Interchange, a Genie Z60 Mobile Elevating Work Platform (MEWP) (Type 9b), ran away for approximately 340 metres whilst in the process of being on- tracked, coming to a stand of its own accord in platform 1 at Bradford Interchange station.

Genie Z60 Type 9b machines shall have the frequency for parking brake brought forward to 3-monthly intervals. This shall remain in place until advised otherwise by the Network Rail's Professional Head of Plant.

The preferred method of testing should be torque testing using the OEM approved method and correct measurement equipment. This shall be completed by a competent fitter and records fed back to Network Rail's Professional Head of Plant via the 'Contact' above.

All Operators, Machine Controllers and POS representatives shall be re- briefed on the correct on/off-tracking procedures.

- All Operators, Machine Controllers and POS representatives shall be re- briefed on the correct completion of pre-start and functional checks, in particular of the service and park brakes.
- Plant owners should target assurance activity on the thoroughness of pre- start checks and completion of relevant documentation (this may be possible through the POS Reps).
- Plant operations that are undertaken in areas where gradients are present shall have a suitable risk assessment for managing that risk and have a detailed recovery plan for failed OTP .
